# Baseline thermography report excerpt

Coral Crest Condominium | Miami-Dade, Florida

## ORIGINAL INSPECTION: SEPTEMBER 21, 2026

Source: 101 - Delta Electrical System Coral Crest Condo, original report dated October 1, 2026; selected original page 12 (Area/Image No. 6). The reproduced source page retains its original findings and labels.

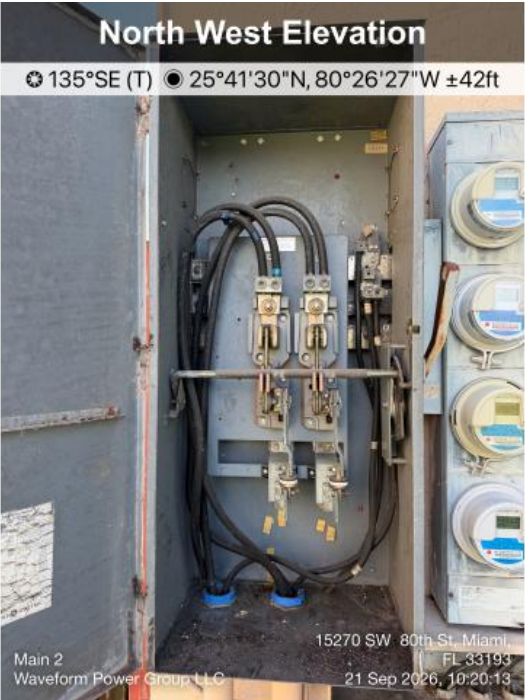
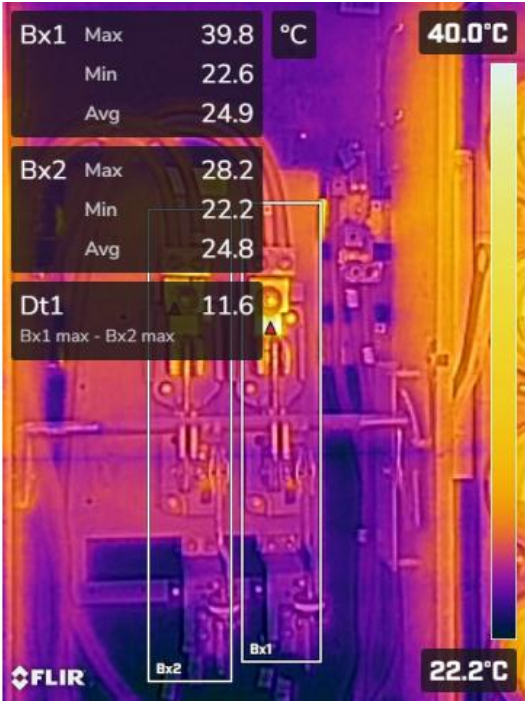
Area/Image No. 6    Job No. 101    Date 09/21/2026    Time 09:44 am

The following page is reproduced from the original condition-assessment report. It documents Main 2 at 15270 SW 80th Street and an apparent 11.6°C difference between the two marked measurement regions.

Ambient Temp 28.00 °C    ΔT 11.60 None    Other Phases

- Apparent ΔT 11.6 °C; verify settings and loading.
- Inspect connection; verify lug suitability and torque.
- Treat enclosure rust; replace deteriorated hardware.
- Restore labels; remove debris; check moisture entry.

The original finding called for verification of settings and loading, inspection of the connection, and verification of lug suitability and torque.
